**FWF  
TRIAL EXHIBIT  
# 63**

# EVERGLADES RECLAMATION STATE HISTORIC SITE

THE MIAMI CANAL LOCK WAS ONE OF THE FIRST WATER CONTROL STRUCTURES DEVELOPED BY THE EVERGLADES DRAINAGE DISTRICT IN THE EARLY 1900'S. IT IS PART OF AN EARLY TRANSPORTATION AND DRAINAGE SYSTEM DESIGNED TO HELP SPEED THE GROWTH AND AGRICULTURAL DEVELOPMENT OF SOUTH FLORIDA.

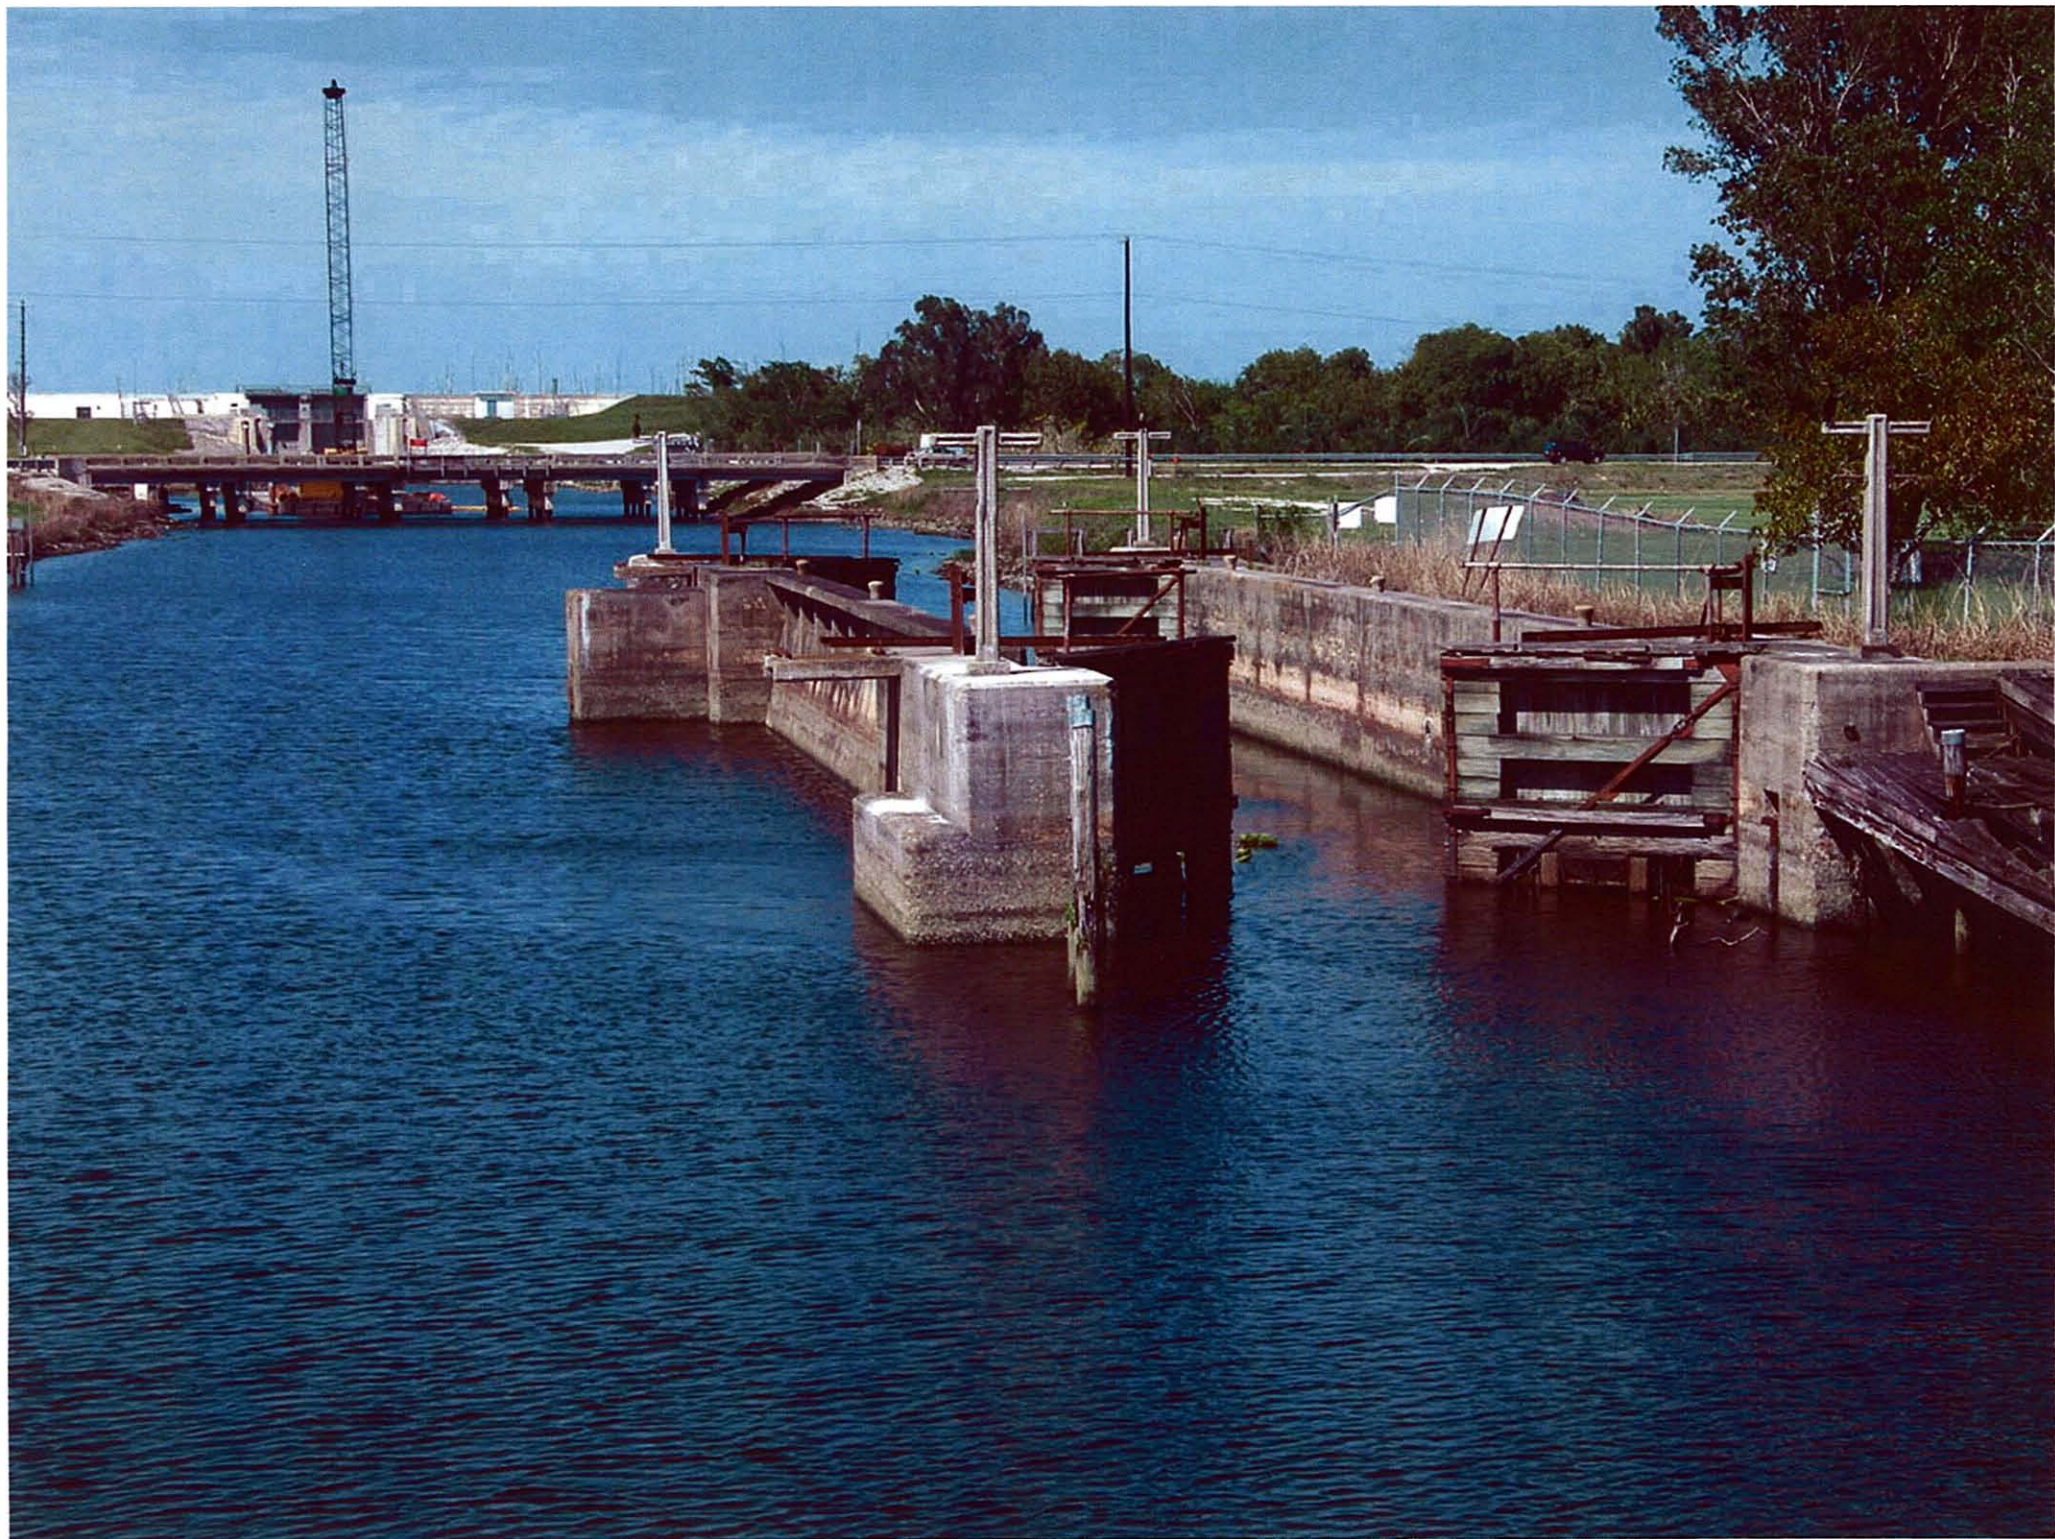
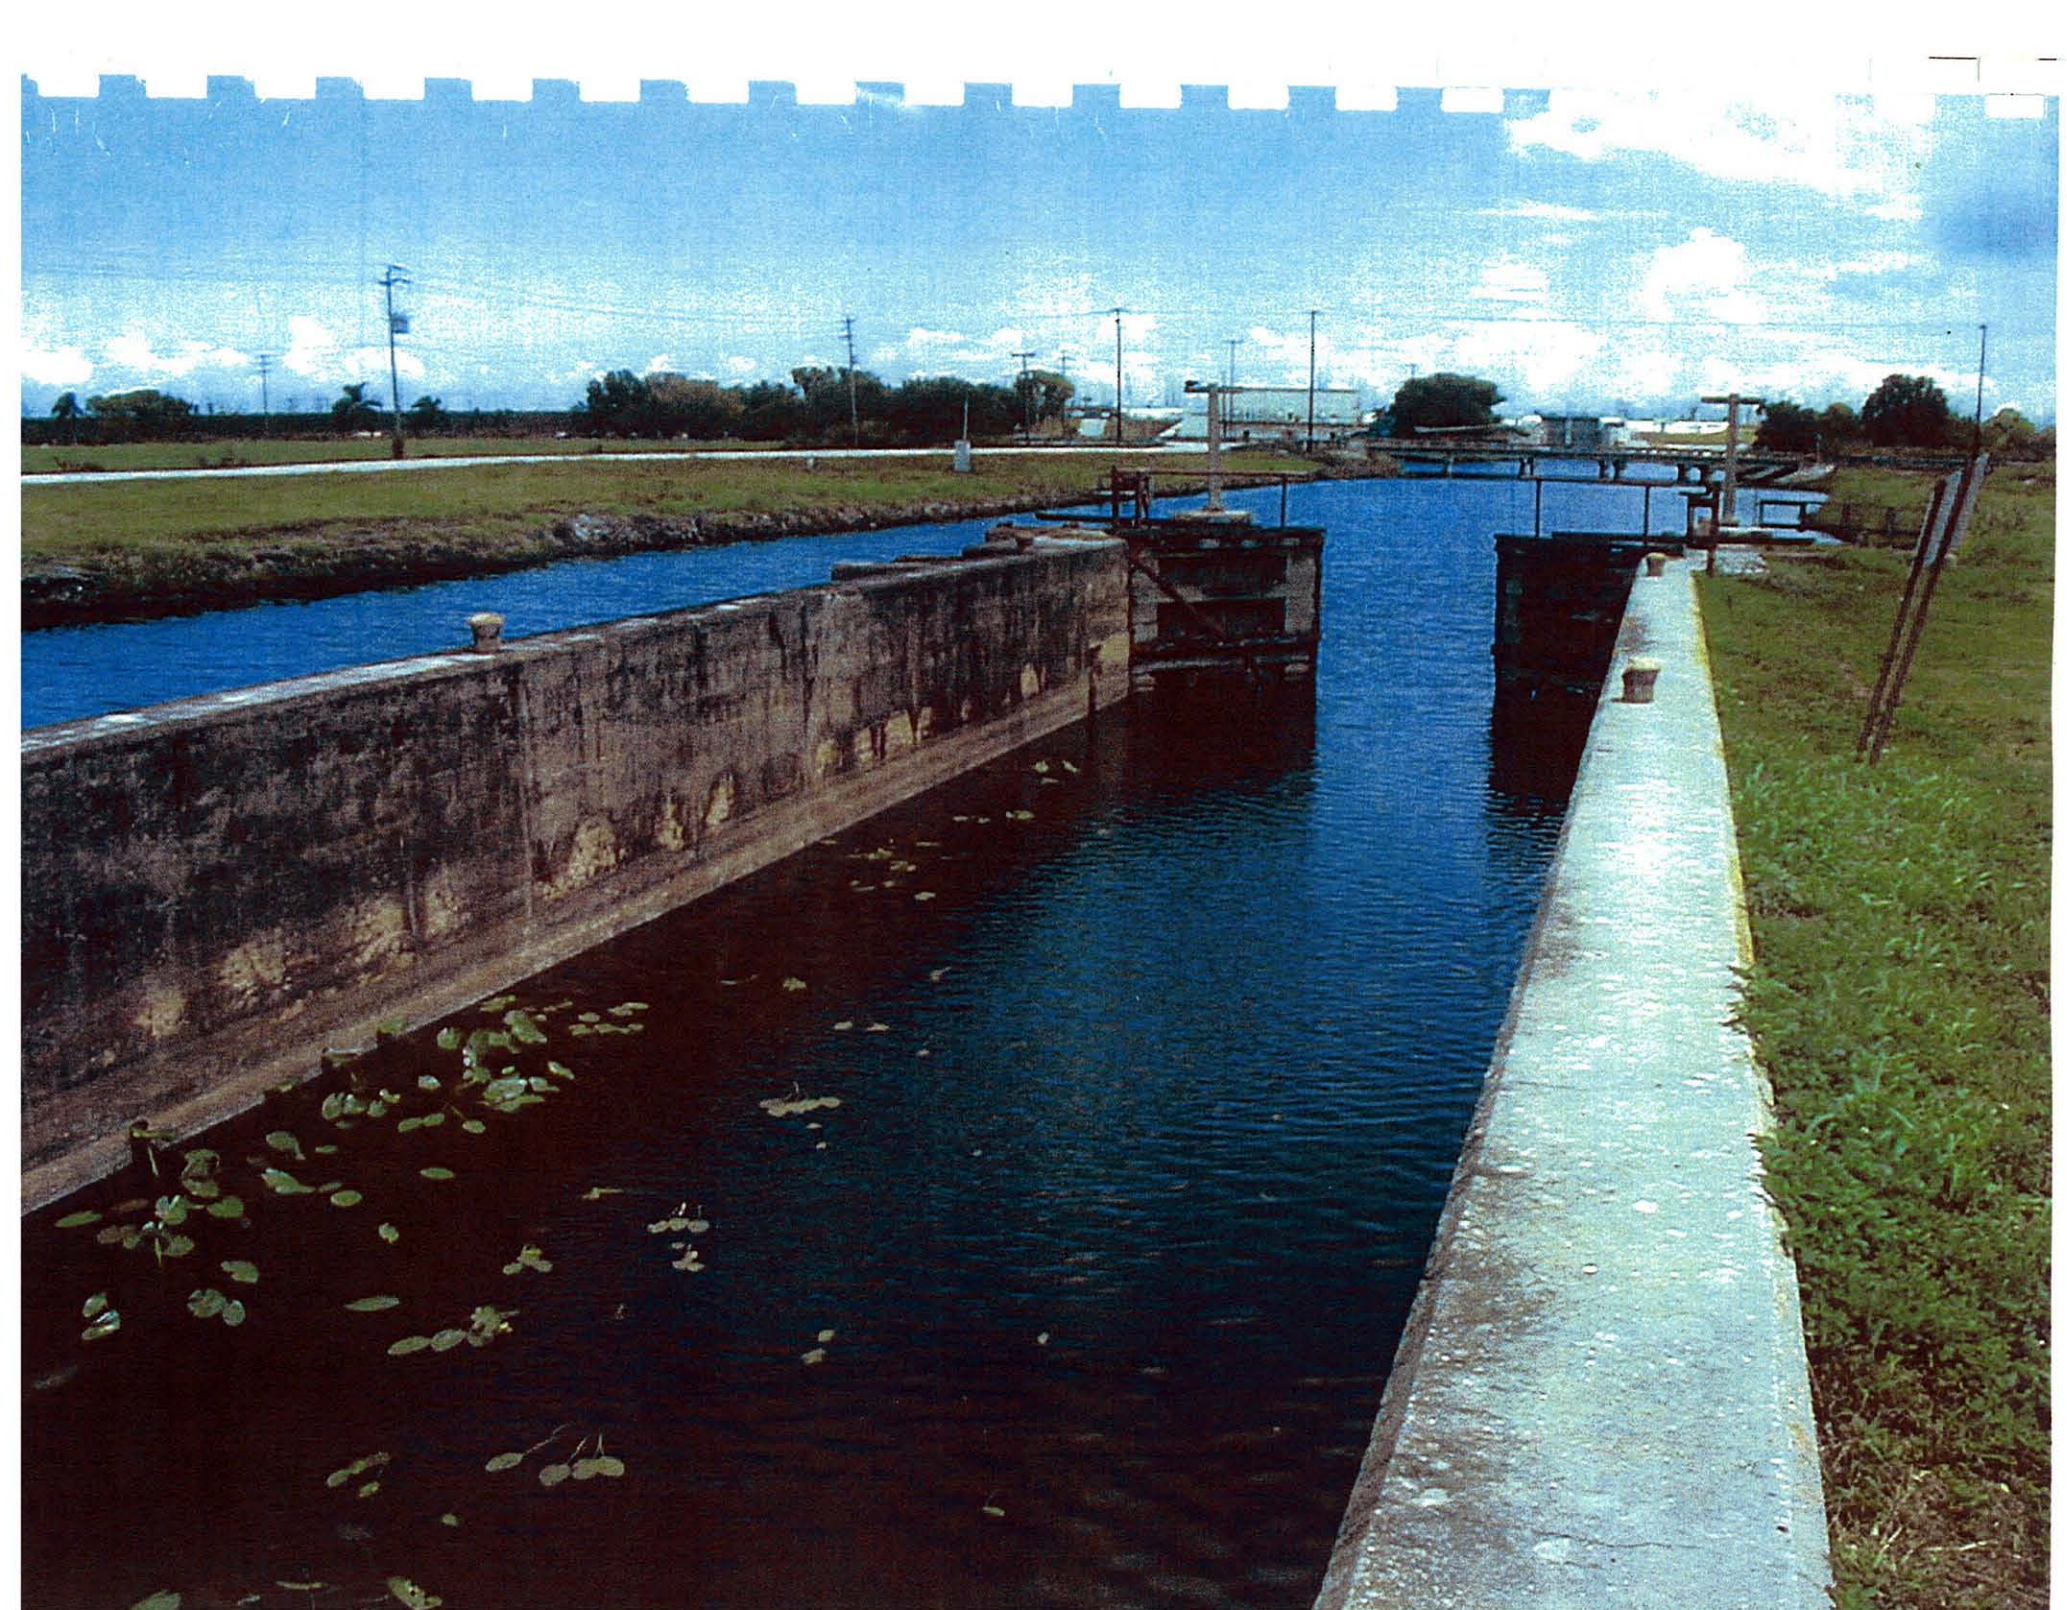
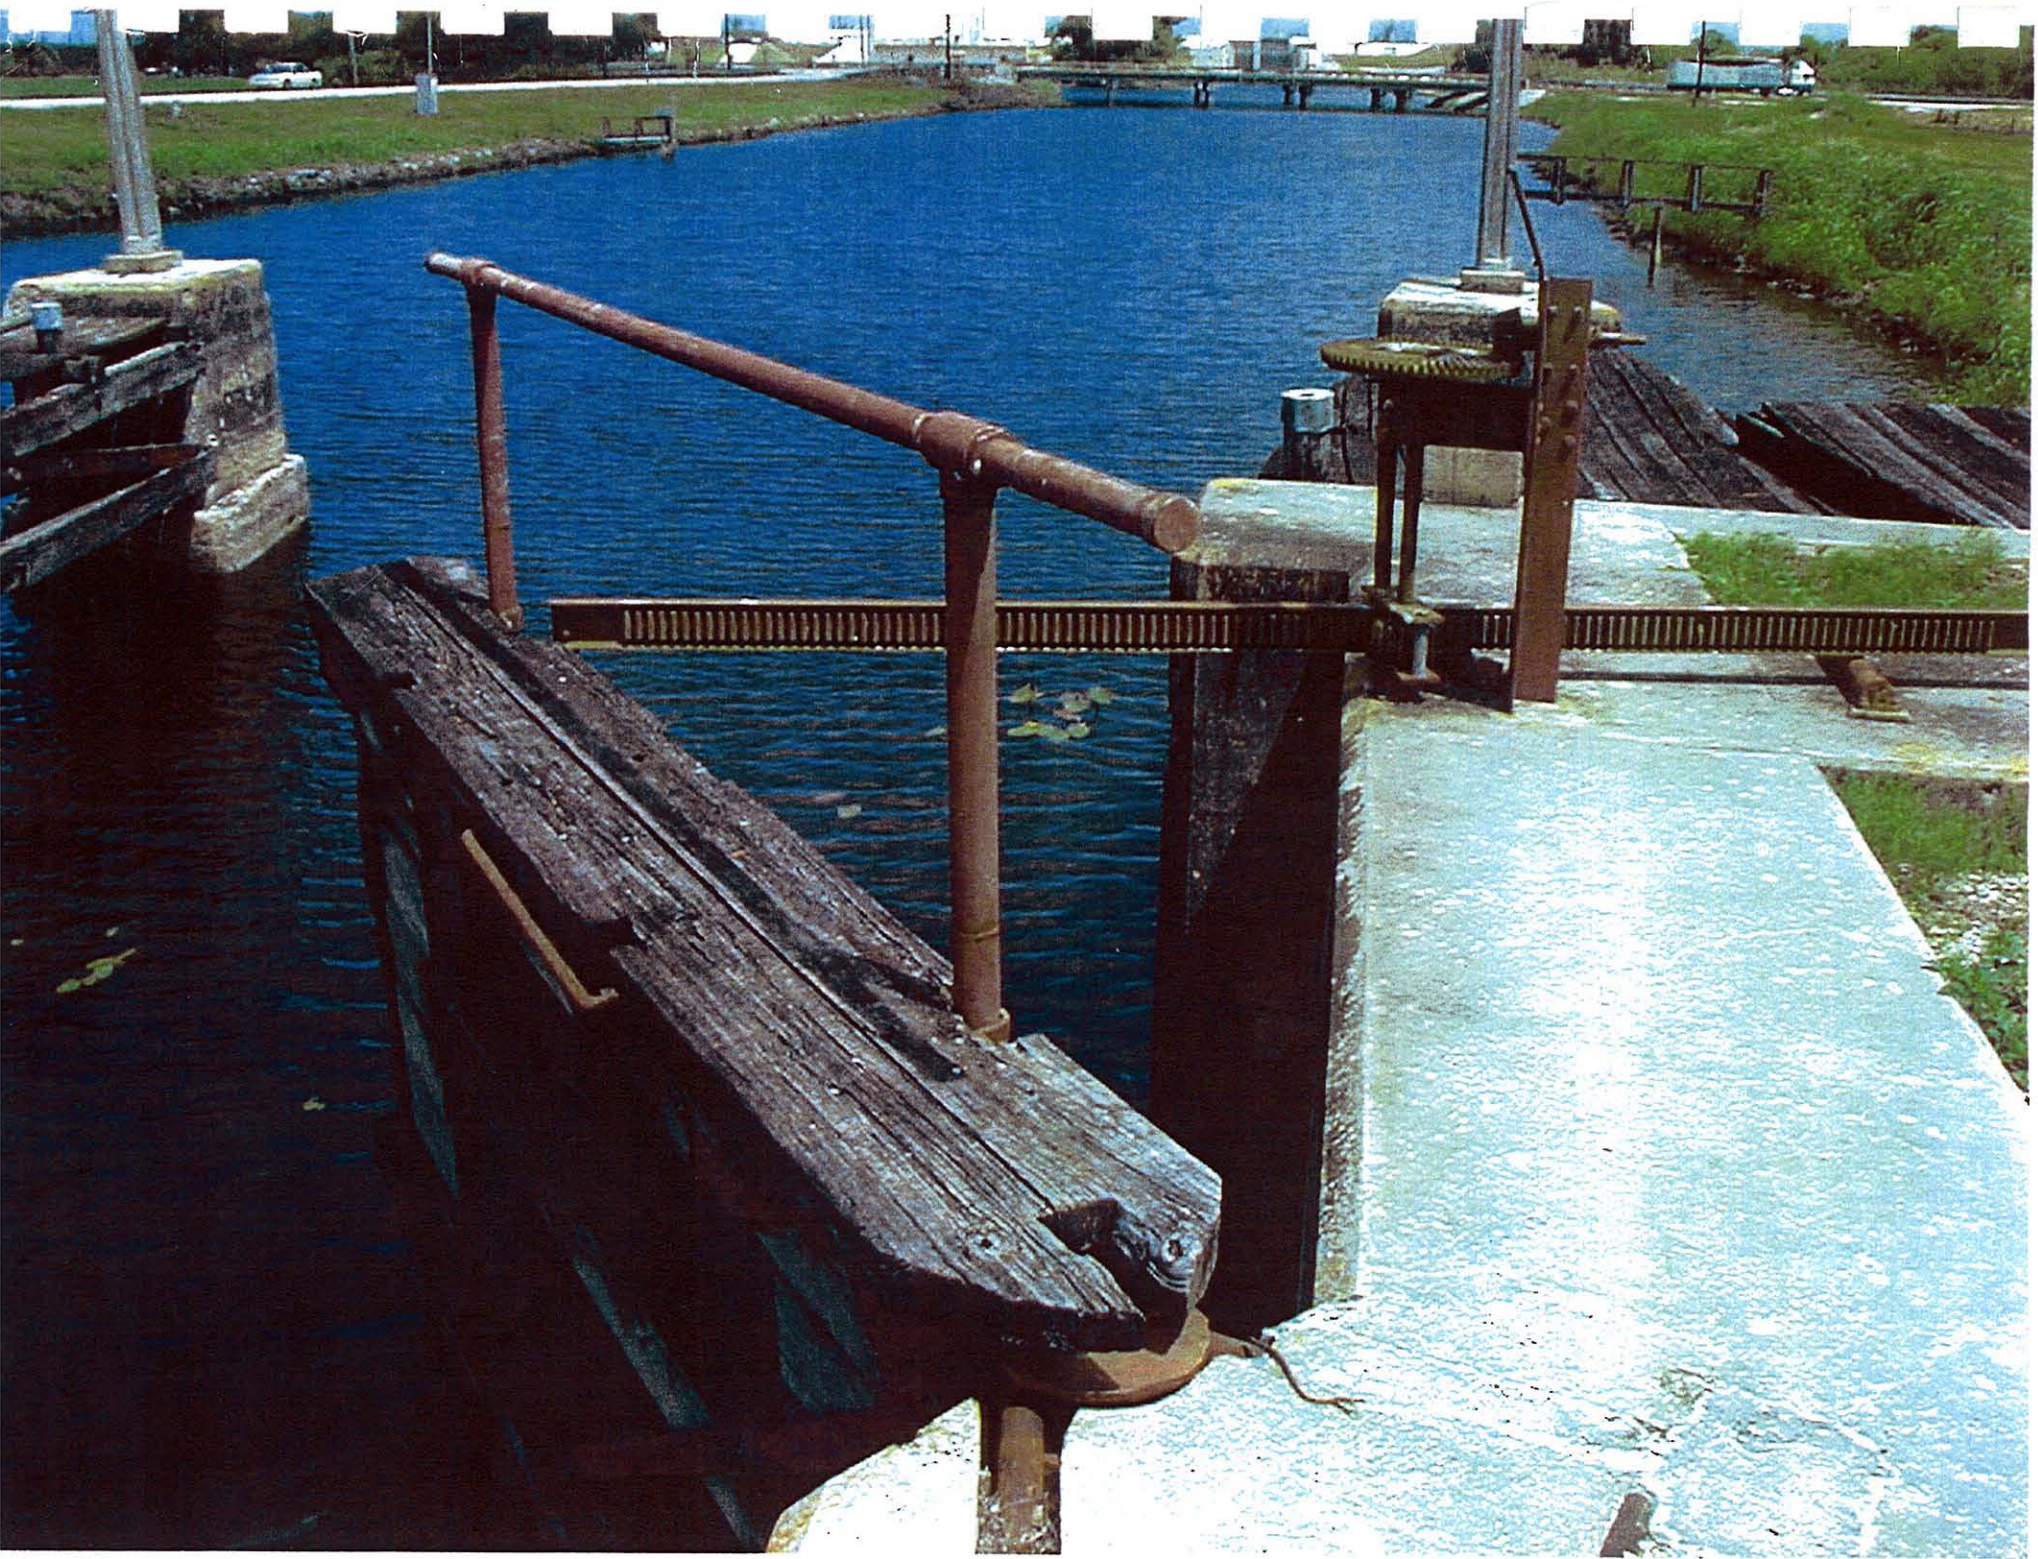
At trial, the South Florida Water Management District had contended that the Lake and the Everglades were historically a single water body on the theory that water levels in both water bodies were essentially the same. The following photographs of the old locks on the Miami Canal demonstrate that water from Lake Okeechobee historically flowed south from the Lake to the Everglades. These locks were originally built in the early 1900's, prior to the construction of the Hoover Dike that now rings the Lake. [A concrete section of the Hoover Dike is visible in the background of photograph number 3]. As explained in the photographs of the signs shown in photographs 1 and 2, boats going from Lake Okeechobee into the River (now channelized and denominated the Miami Canal) had to be lowered by 3 to 4 feet as they went through the locks. Photographs 3, 4 and 5 show that the doors of the lock faced up stream so that the force of the higher water on the Lake Okeechobee side kept them closed.

AS THE NORMAL DIFFERENCE IN ELEVATION BETWEEN LAKE OKEECHOBEE AND THE MIAMI CANAL WAS THREE AND A HALF TO FOUR FEET, THIS LOCK WAS CONSTRUCTED IN 1919 TO LIFT OR LOWER A BOAT THROUGH THE DIFFERENCE IN WATER LEVELS.

BOATS MOVING DOWN THE CANAL FROM LAKE OKEECHOBEE WERE LOWERED BY ENTERING A FULL LOCK THROUGH THE UPPER GATES. WHEN THE BOAT WAS IN THE LOCK, THE UPPER GATES WERE CLOSED AND THE WATER WAS RELEASED THROUGH THE PADDLES IN THE LOWER GATES. THESE SMALL IRON PADDLEGATES, LOCATED NEAR THE BOTTOM OF THE LARGE WOODEN LOCK-GATES, ADMITTED AND RELEASED WATER FROM THE LOCK CHAMBER. WHEN THE LEVEL OF WATER IN THE LOCK REACHED THAT OF THE LOWER LEVEL OF THE CANAL, THE GATES WERE OPENED AND THE BOAT PASSED OUT ON ITS WAY SOUTH. THIS PROCESS WAS REVERSED FOR BOATS GOING UP THE CANAL.
